Forensec (uk) Ltd

FIRE SAFETY AUDIT

Company: Gateways School	Date of Visit: 17 th August 2017
Address: Gateways School Harewood Leeds LS17 9LE	Fire Risk Assessment: June 2011 Last Audit: 3 rd June 2016 Comments: All issues raised in our previous audit have been addressed and the site continues to make progress in all fire safety areas.
Responsible Person: Dr. Tracy Johnson; School Principal	Those items indicated by an asterisk (*) are contraventions of the Fire (Scotland) Act 2005 , and as such may become the subject of a prosecution following an inspection by the Local Authority Fire Brigade or enforcing authority as appropriate. Accordingly, those items must receive immediate attention.
Contact: Chris Furminger Operations Manager	
Fire Safety Consultant: Michael J Pierce. Grad.I.FireE., M.I.F.S.M. Ex District Officer West Yorkshire Fire Service. Fire Safety Managers Fire Risk Assessor register. Listing 0007 Warrington Certification Ltd, F.R.A.C.S. Risk Assessor's Register, Listing 0020	Is there risk of enforcement action: <input type="checkbox"/> Yes <input checked="" type="checkbox"/> No

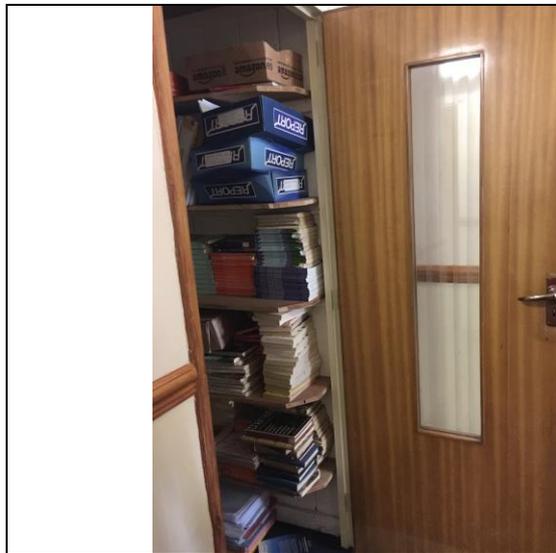
Figure 1

5.5 Fire Separation					
a. The stationery store is not ½ fire resisting.	Occupants of the main house.	a. The door needs to be FD30s, i.e. 1/2-hour fire resistant and fitted with intumescent strips and smoke seals. The screen into which the door is set should offer the same fire resisting quality, i.e. ½ hour.	SHORT TERM	1

This stationery store should be able to protect the means of escape from any fire within it. The door needs to be FD30s standard, i.e. 1/2-hour fire resistant and fitted with intumescent strips and smoke seals. The screen into which the door is set should offer the same fire resisting quality, i.e. ½ hour. This can be enhanced by the use of 6mm polished Georgian wired glazing over the door to allow borrowed light.

It is understood that this store has been the same for many years, unfortunately it has been missed from previous audits

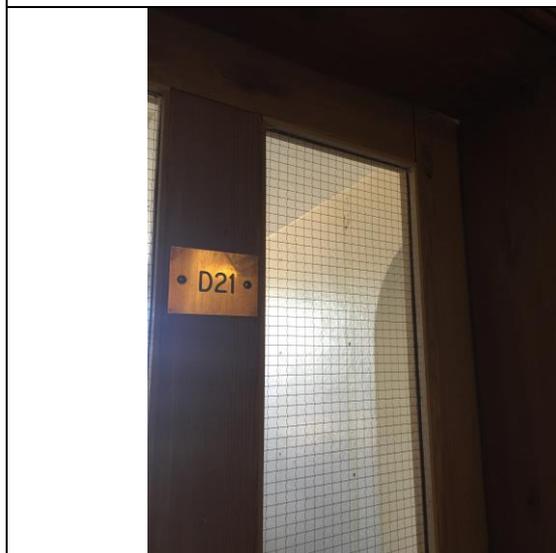
Figure 2

b. The door to room D21 has been greatly improved by the addition of new hinges, intumescent strips and cold smoke seals. However, there is a visible gap in the top right of this photograph which would allow the passage of heat, smoke and other products of combustion negating the good work that has been done.	Occupants of the main house.	b. Either Increase the depth of the top of the frame by The addition of timber, minimum of 25mm in thickness of suitable density which is screwed and glued at 30cm centres or provide a similar bed under the new seals.	SHORT TERM	2

One of several doors which have been greatly improved by the addition of new hinges, intumescent strips and cold smoke seals. However, there is a visible gap in the top right of this photograph which would allow the passage of heat, smoke and other products of combustion negating the good work that has been done.

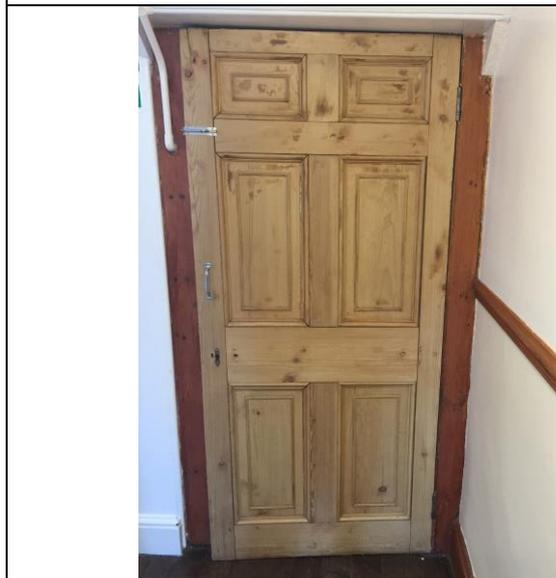
Figure 3

This cleaner's cupboard was found to be open and unattended. It is recommended that a suitable 'FIRE DOOR – KEEP LOCKED SHUT' sign be displayed upon it.

<p>5.8 Testing and Records</p> <p>Good records of testing continue to be maintained and provide robust documentary evidence of statutory requirements being met. It is recommended that all fire related records are retained for a minimum of 3 years and held in a wall mounted fire proof document safe. Specific tests area as below:</p> <p>Fire alarm weekly in house Emergency Lighting monthly in house Fire alarm all tests by contractor Emergency lighting all tests by contractor Fixed wire August 2017 P.A.T. July 2017 Gas Safe Kitchen 16.07.2017 Boilers September 2016 Lightning Protection 20.12.2016</p>					
<p>5.9 Fire Signage</p> <p>The 1st floor cleaner’s cupboard was found to be open and unattended.</p>	<p>Occupants of main house</p>	<p>Cupboards such as the should be secure when unattended. It is recommended that the store be locked when not in use and a sign displayed upon the door. E.G.:-</p> <div data-bbox="1070 1114 1227 1273" data-label="Image"> </div>	<p>IMMEDIATE</p>
