Forensec (UK) Ltd

FIRE SAFETY AUDIT

Company: Gateways School	Date of Risk assessment Visit: 22 nd September 2022
Address: Gateways School Harewood Leeds LS17 9LE	First Fire Risk Assessment: June 2011 Last Audit: August 2021 Comments: 31 st
Responsible Person: Dr. Tracy Johnson; School Principal	Those items indicated by an asterisk (*) are contraventions of The Regulatory Reform (Fire Safety) Order 2005 and as such may become the subject of a prosecution following an inspection by the Local Authority Fire Brigade or enforcing authority as appropriate. Accordingly, those items must receive immediate attention.
Contact: Phil Robinson Operations Manager	
Fire Safety Consultant: Michael J Pierce. Grad.I.FireE., M.I.F.S.M., FRACS Ex District Officer West Yorkshire Fire Service. Fire Safety Managers Fire Risk Assessor register. Listing 0007 Warrington Certification Ltd, F.R.A.C.S. Risk Assessor's Register, Listing 0020	Is there risk of enforcement action: <input type="checkbox"/> Yes <input checked="" type="checkbox"/> No

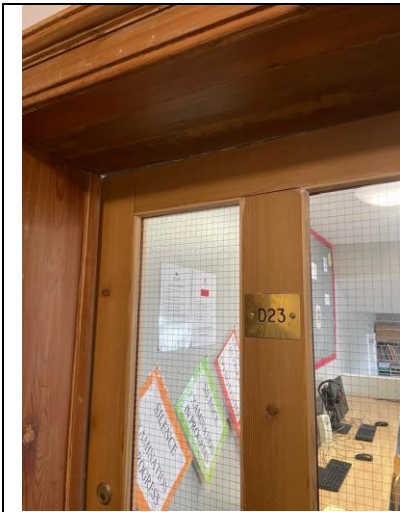
Figure 1

SIGNIFICANT HAZARDS	PERSONS AT RISK	ACTION REQUIRED	WHEN	PHOTO	BY WHOM (SIGNATURE)
5.1 Means of Escape					
a. Some doors are showing excessive gaps beneath the, eg. Door to room D23, and the corridor division door shown in figure 4	ALL OCCUPANTS	a. All doors which protect the means of escape need to be installed in accordance with accepted parameters. These are that gaps around the sides and top are between 2 and 4mm. Gaps at the bottom of doors should be preferably 8mm but no more than 10mm. The doors should also close fully into their frames from any angle of release	IMMEDIATE	1, 4

D23, does not close effectively and there are gaps at the top.

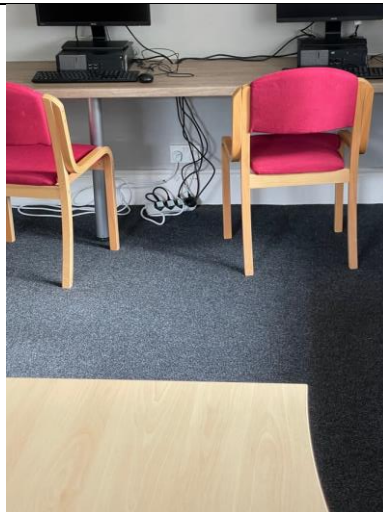
Figure 2

5.6 General Housekeeping/ Maintenance					
<p>The new computer suite in the old building has been set up with reliance upon trailing sockets.</p>	ALL OCCUPANTS	<p>It is recommended that a competent electrical engineer be appointed to evaluate the specific requirements of the installation. His recommendations should be carried out.</p>		2

Over use of trailing sockets.

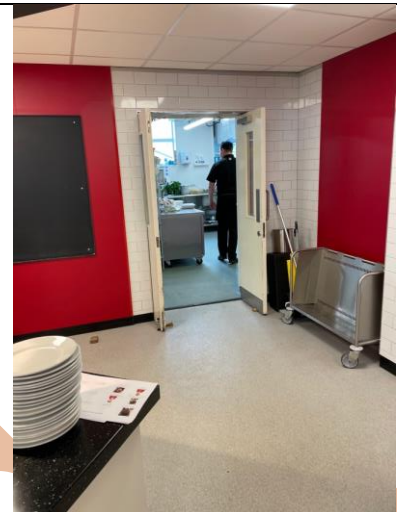
Figure 3

<p>c. The fire resisting kitchen doors were found to be wedged open during meal service. This is considered acceptable as they are closed at the end of service and if self-closing would be considered a danger to persons carrying hot dishes and other items from the kitchen to the servery.</p>		<p>c. No action required other than ensuring closure at the end of service.</p>		3

Kitchen doors wedged during service. Acceptable.

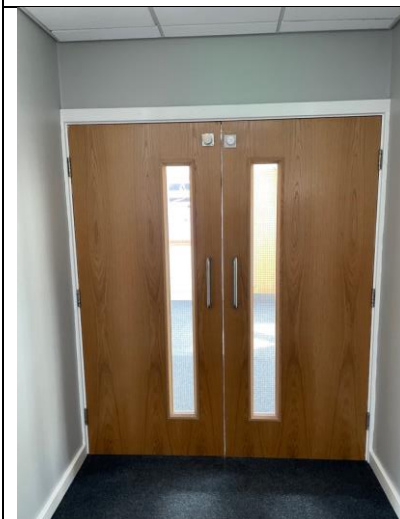
Figure 4

Gaps between fire check corridors.

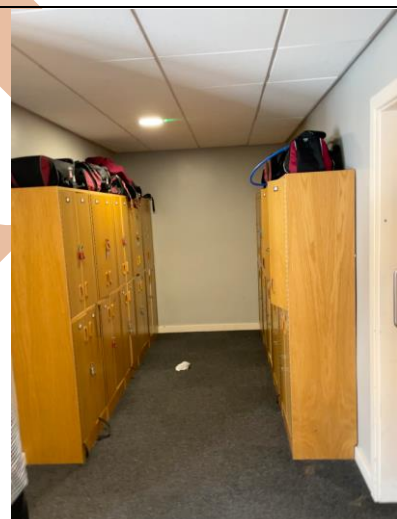
Figure 6

As in 5

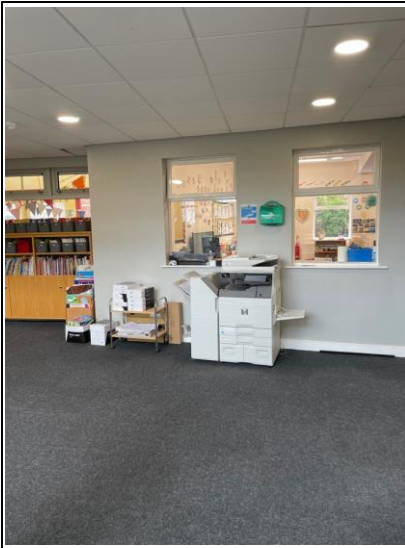
Figure 7

Photocopier on means of escape plus associated combustible material.

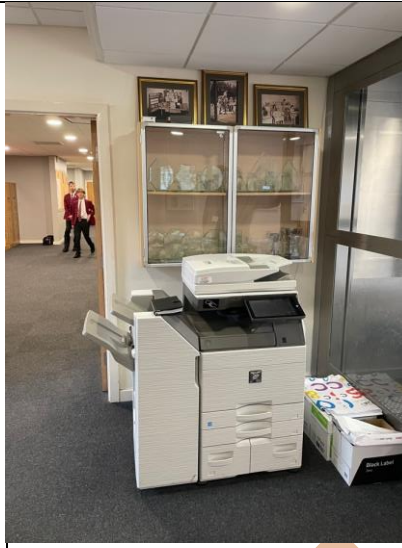
Figure 8

As in 7

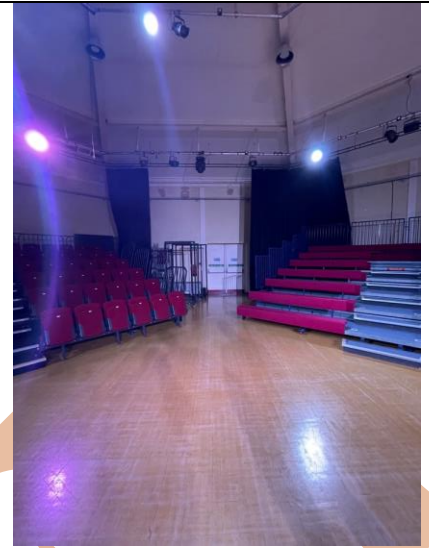
Figure 9

Theatre signage not sufficient

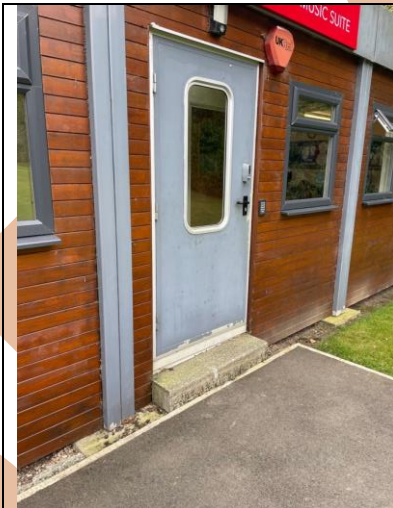
Figure 10

b. The final exit from the music pod opens directly over a step. This is a trip hazard.	ALL OCCUPANTS	b. Outward opening doors should open over a landing not a step. Construct a landing to provide level going extended to 300mm beyond the leading edge of the door when open in its widest position.	SHORT TERM	10

Means of escape opening over a step.

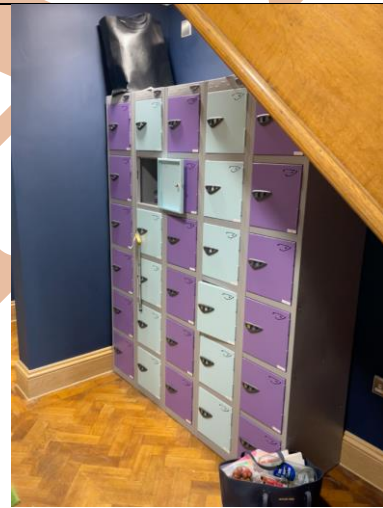
Figure 11

5.5 Fire Separation					
<p>a. Photocopiers are installed on the means of escape in Schofield. This and the accompanying items and office equipment introduces a fire loading and risk of ignition onto the means of escape.</p>	ALL OCCUPANTS OF SCHOFIELD AND EARLY DAYS	<p>a. This was discussed after the previous visit and it was agreed that the possibility of introducing other measures would be able to accommodate this. However, the situation has not changed and the area in which the printer is located is fundamental to the means of escape from the office and all classrooms along the early days corridor. These now require relocating to a room or area separated from the means of escape.</p>	IMMEDIATE	7, 8	
<p>b. Substantial lockers are sited on corridors providing means of escape, this is considered acceptable due to the nature of the occupancy and the comprehensive installation of fire detection equipment. However, additional baggage and other items have started to be stored on or around the lockers. This includes the new 6th form centre.</p>	ALL OCCUPANTS	<p>b. Remove the bags and other items and monitor. If this cannot be controlled then remove the lockers.</p>	IMMEDIATE	5, 6, 11

Lockers on means of escape with additional baggage around them and on top.
